INCIDENT DESCRIPTION

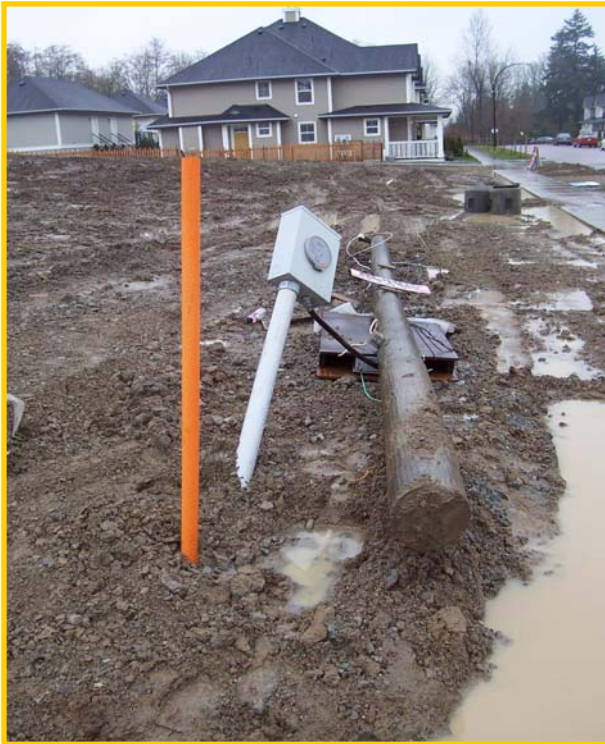
A sub-contractor was grading a park using a mini-excavator to prep the site for installation of a parkette. The sub-contractor came across two signs and a pole. The pole was connected to a BC Hydro Panel. After discussing it with a City Coordinator it was decided that it was safe to remove the pole. However, the City Coordinator did not know that the pole was attached to a live BC Hydro low voltage power line. The sub-contractor began to move the pole until he realized it was still connected to an aboveground meter box. The job was stopped and BC Hydro was called to de-energize the pole. Fortunately the incident did not result in the release of hazardous energy.

Low voltage power is hazardous and could have seriously injured a worker.

Failure of City staff (Prime Contractor/Owner) to identify that the pole was connected to a power source and poor judgment to authorize the removal of the pole.

1. Perform a visual inspection when removing a pole to ensure it has no connections attached to it.
2. If there are connections still attached, do not remove the pole.
3. Call BC Hydro or an Electrical Inspector to provide advice and to ensure that the pole is not connected to live power.
4. The pole can be safely removed once it is confirmed that all live connections have been removed.
