## INCIDENT DESCRIPTION

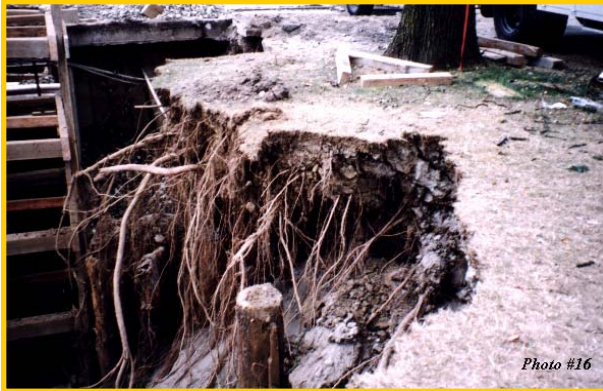
A City of Vancouver Engineering crew was installing shoring sets in an excavation prior to sewer pipe maintenance/installation. Two sets of shoring had been installed and excavation of an additional 5m length was being done in preparation for the third set. While excavating, the equipment operator came upon some old wooden dock pilings that were 1 m below the surface. The excavator removed the buried pilings which caused the trench to slough, exposing a significant amount of the root structure of a 30m tree

immediately adjacent to the excavation. The foreman stopped the work and called the Arboriculture Department. Arborists from this workgroup determined that the tree was stable, yet a high wind warning for the evening, coupled with the high traffic location (Terminal Avenue), prompted the Arboriculture group to initiate removal of the tree.

The utility arborists conducted a tailgate meeting to determine the next course of action. The decision was made to use an aerial bucket truck to access and remove/delimb the tree in sections. A spotter was used to help ensure safe placement of the bucket truck and to keep pedestrians away from the work site. The site was located at both a very busy intersection and a Skytrain pedestrian walkway. The arborist, manoeuvring the bucket as needed, proceeded to delimb branches from the tree. The skytrain and aerial lift bucket were working side by side. When a skytrain entered the station, pedestrians disembarked from the train and proceeded to exit the terminal. The spotter, who was observing the location of the boom in relation to the skytrain track, became busy directing the pedestrians away from the worksite. Unknown to the aerial lift operator or the spotter, the knuckle of the boom had moved over the guideway, and into the path of any oncoming skytrain. When the next skytrain departed the terminal, it struck the knuckle on the boom, just enough to create a spring action, so the knuckle kept bouncing and striking the train repeatedly as it passed.

1. Trench collapse due to unstable soil.
2. Equipment (with operator) struck by skytrain.
3. Injury and damage from falling debris.

1. Soil adjacent to tree sloughed exposing root ball.
2. Operating too close to Skytrain tracks / guideway.

1. Develop safe work procedures while working within proximity of Skytrain.
2. Contact Skytrain to provide supervision
